Manhole Inspection Summary

Manhole # S31II_027MH

Insp Date: **4/6/07 11:53 AM**

Location Address: **1436 MOSHER ST**

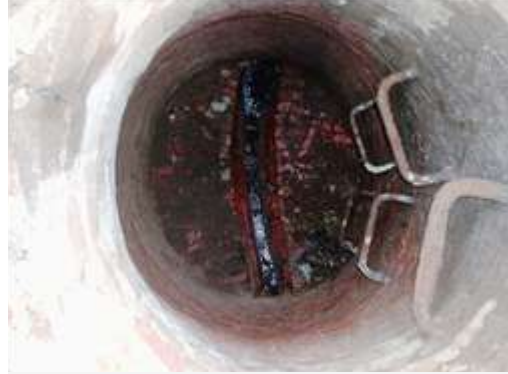
Top View

Bench ☒ Exists Material: **Brick** ☐ Parged ☒ **Debris** (not Condition related)
Condition: ☒ Sound ☐ Cracked ☐ Root Intrusion ☐ Deteriorated ☐ Leaks ☐ Debris

Steps Count: **5** Missing: **0** ☒ **Corroded**

Surcharge ☒ **Evidence Of Surcharge** Depth: **2** (ft.) ☐ Active Surcharge Present

Corroded steps. Evidence of surcharge - Bench debris.

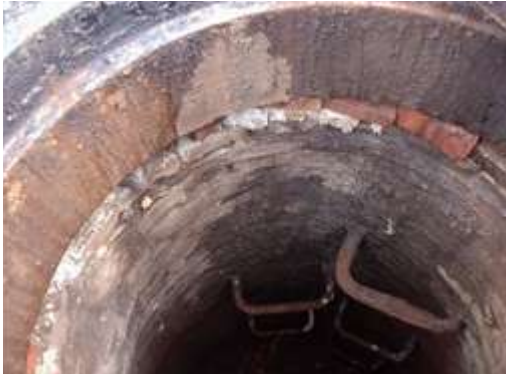
Defect

Frame Offset: **1** (in.) Condition: ☐ Sound ☐ Cracked ☒ **Leaks**

Chimney / Frame Adjustment ☒ Exists Material: **Brick** ☐ Parged Height: **15** (in.)
Condition: ☐ Sound ☐ Cracked ☐ Root Intrusion ☐ Loose Brick ☒ **Deteriorated**
Infiltration: ☐ None ☒ **Joint** ☐ Cracks ☒ **Mortar** ☐ Roots ☐ Wall

Corbel Material: **Brick** ☐ Parged Type: **Concentric/Eccentric**
Condition: ☒ Sound ☐ Cracked ☐ Root Intrusion ☐ Loose Brick ☐ Deteriorated
Infiltration: ☐ None ☐ Joint ☐ Cracks ☐ Mortar ☐ Roots ☒ **Wall**

Frame leaks. Adjustment deterioration and infiltration. Corbel infiltration - other side.

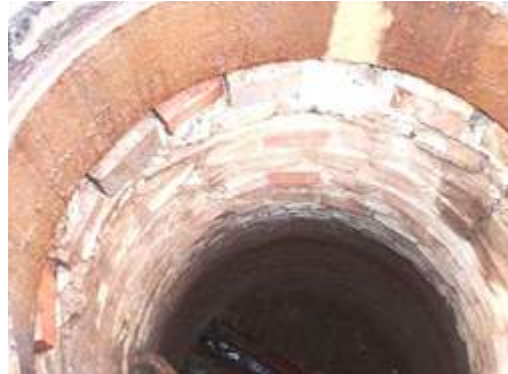
Defect

Frame leaks. Adjustment deterioration and infiltration. Corbel infiltration.

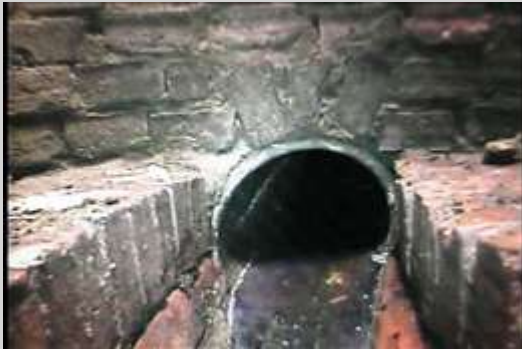
8 in. Circular Gravity Sewer Pipe Out @ 12 O'Clock

Channel deterioration.

Deposits: ☐ None ☒ **Mud** ☐ Sludge ☒ **Debris** ☐ Grease

Silt Depth: **0.5** (in.) Deposits Extent: **Light**

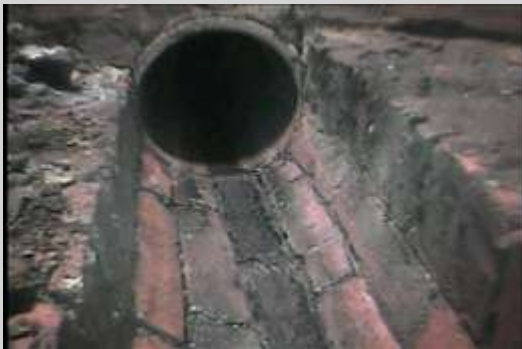
8 in. Circular Gravity Sewer Pipe In @ 6 O'Clock

Infiltration: **Evidence** Pipe Seal Cond: **Cracked**
